OAK RIDGE NATIONAL LAB TN

ORNL-5541

**Blast Tests of Expedient
Shelters in the Misers
Bluff Event**

FINAL REPORT • JANUARY 1980

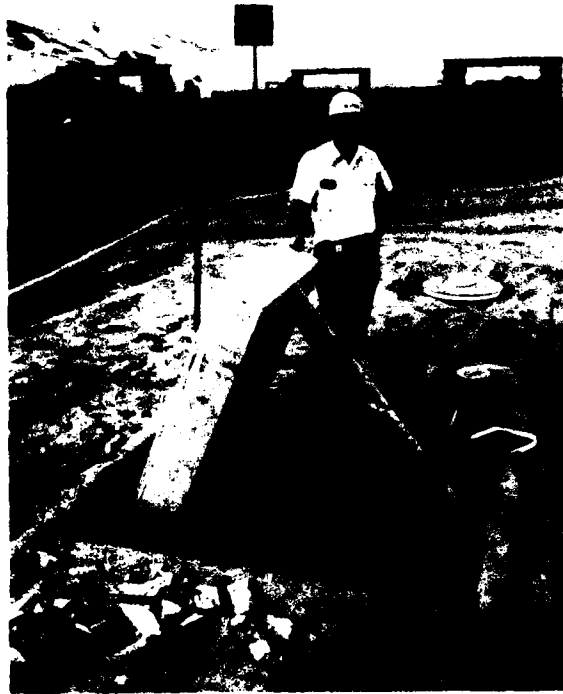
ORNL PHOTO 4164-78

Fig. 6.5. Expedient blast door made of lumber and plywood and designed to withstand 690-kPa (100-psi) blast effects. Note the four blast-protector logs around the door.

- The blast door was almost broken in two (see Figs. 6.8 and 6.9), but it had prevented the shock wave or consequential overpressure from entering the shelter. All of its 2 x 6 in. (41 x 143 mm) beams were broken, as was the plywood on its lower side. However, since the door had been secured with only two 60-penny (15-cm, or 6-in.) nails at the lower ends of its hold-down wires, the negative overpressure tore the door open. (In a previous blast test, fourteen 60-penny nails were used to nail a flattened, horizontal pole to the vertical poles on one side of the entry, and the hold-down wires were connected to this strongly nailed horizontal pole. This attachment system proved to be dependable, as described and pictured in Fig. 6.10 and an earlier blast-test report.²)

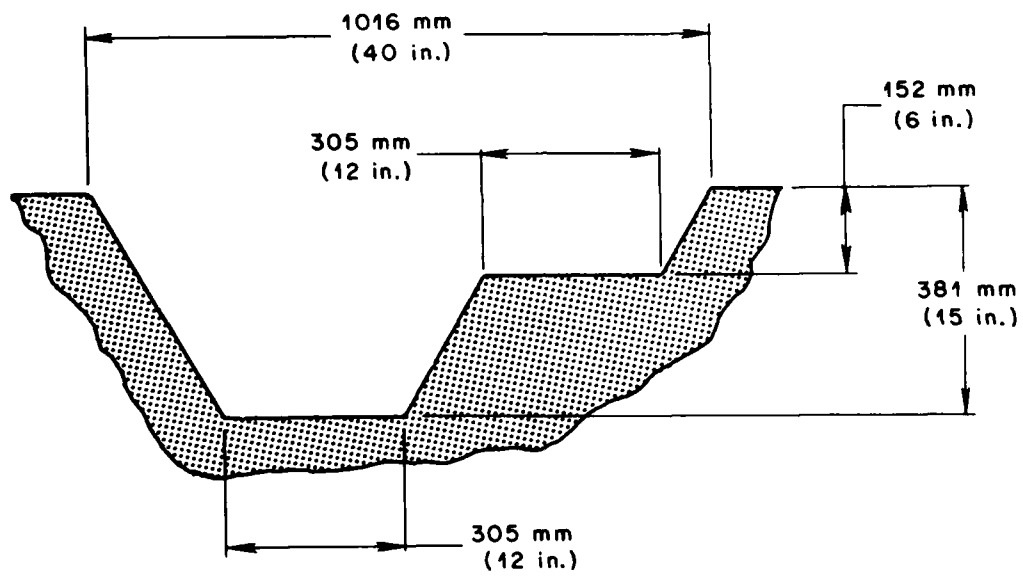
ORNL-DWG 79-18257

Fig. 7.3. Preblast dimensions of the unshored earth seat and foot trench of the Chinese A-Frame Pole Shelter.

Occupants of this shelter would not have been injured by the blast, with the exception of a person who might have been sitting with his head near the one wall pole that was broken (see Fig. 7.10). One wall pole and one pole closing the end of the shelter room were cracked. The rapid inward squeezing of the unshored, sloping earth walls of the foot trench near one end reduced its width from 30 cm (12 in.) to 10 cm (4 in.). This movement probably would have pushed occupants' feet upward, without hurting them (compare Figs. 7.3 and 7.11). The other end of the foot trench was partially collapsed.

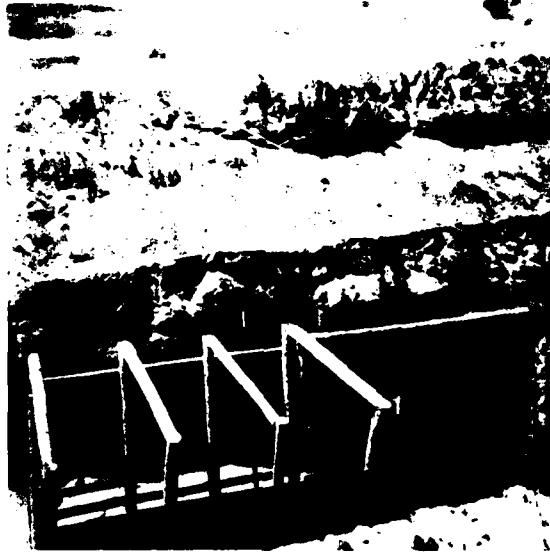
ORNL PHOTO 4253-78

Fig. 8.2. Shored trench being built as a free-standing structure, to be surrounded and covered with very unstable, loose earth. The four-piece frames were spaced every 76 cm (2 ft 6 in.). On the nearer side, these frames pressed against plywood that was to be the shoring in direct contact with backfilled earth.

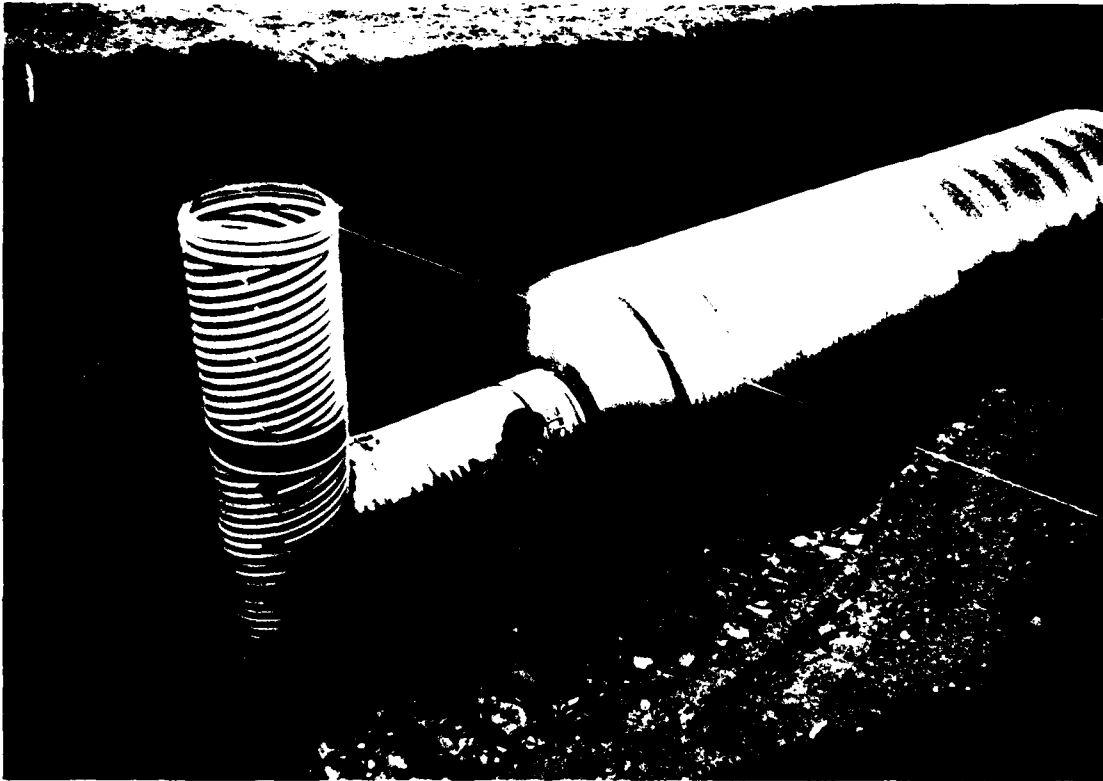
Fig. B.4. A completely assembled Donn Corporation steel blast shelter in its trench, being covered with 1.2 m (4 ft) of earth. With its improved blast door and blast valve (successfully tested in MISERS BLUFF, Event II-II), this shelter should give reliable protection against all blast effects of large nuclear explosions up to the 345-kPa (50-psi) overpressure range. Protection against all radiation dangers should be good--except for those resulting from the probable postblast entry of some windblown fallout particles through the open blast valves, which are only a few inches above ground level.
